Navajo Abandoned Uranium Mine

Site Screen Report

Yazzie No. 102 AUM Site

Navajo AUM Western Region

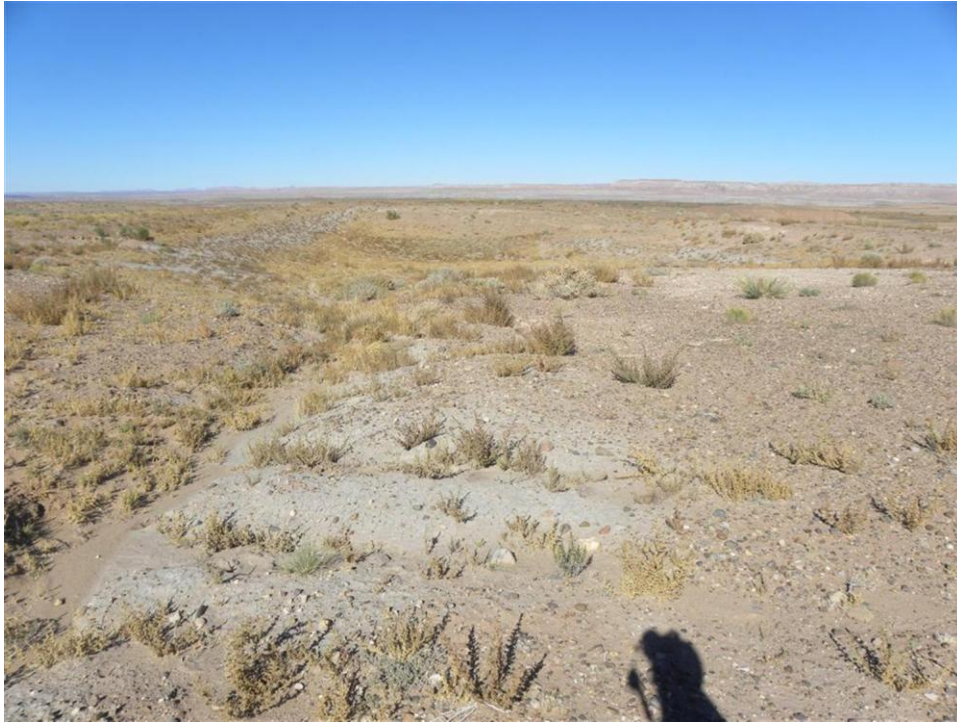
Photo 1. Yazzie No. 102 mine site

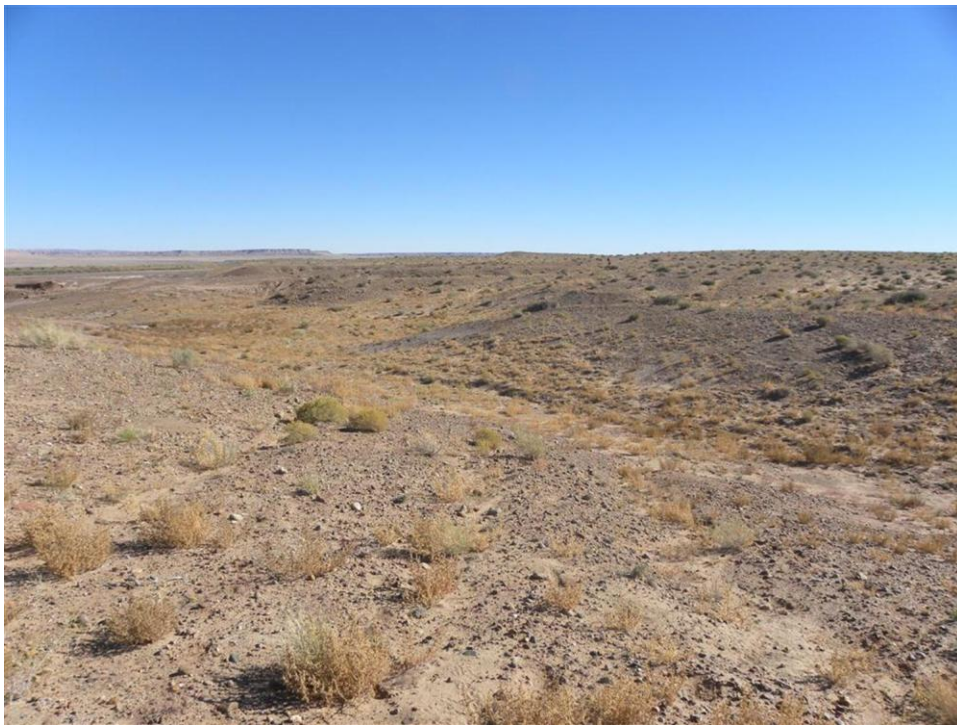
Large depression in the center of the site

Photo 2. Yazzie No. 102 mine site, depression area

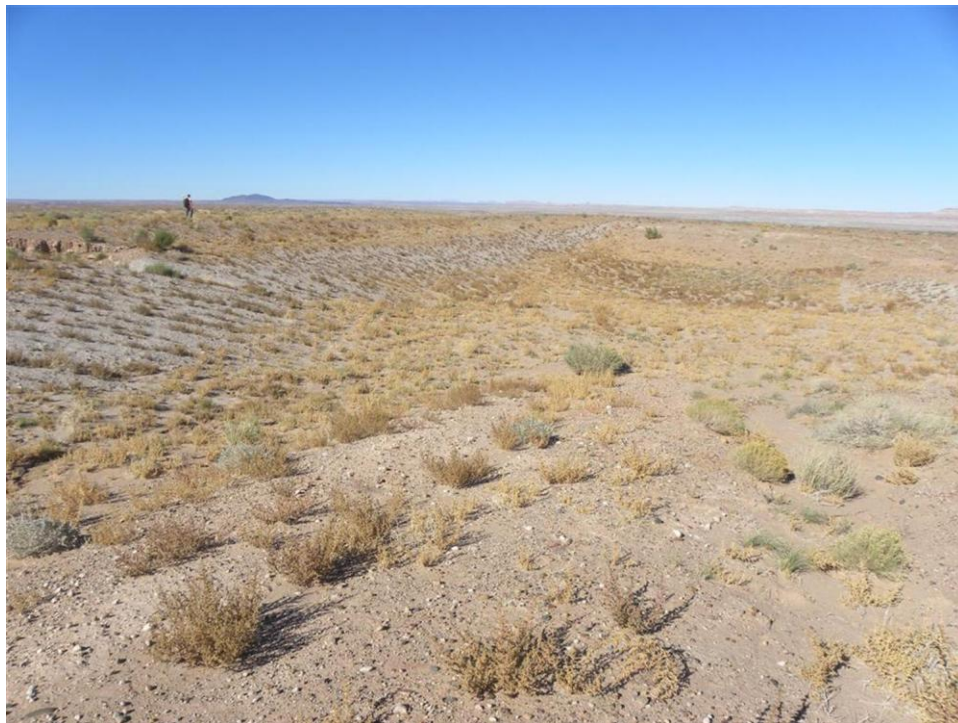
Photo 3. Yazzie No. 102 mine site, depression area
